MEMO TO FILE

The following information, Photos, has been separated from the rest of the original documents belonging to site, Bath Elec Systems (BES) ID # TXD065103327, because the material could not be stored at the Federal Records Center due to certain storage restrictions.

TDD# 06-8590-98 Pg. 1 of 20

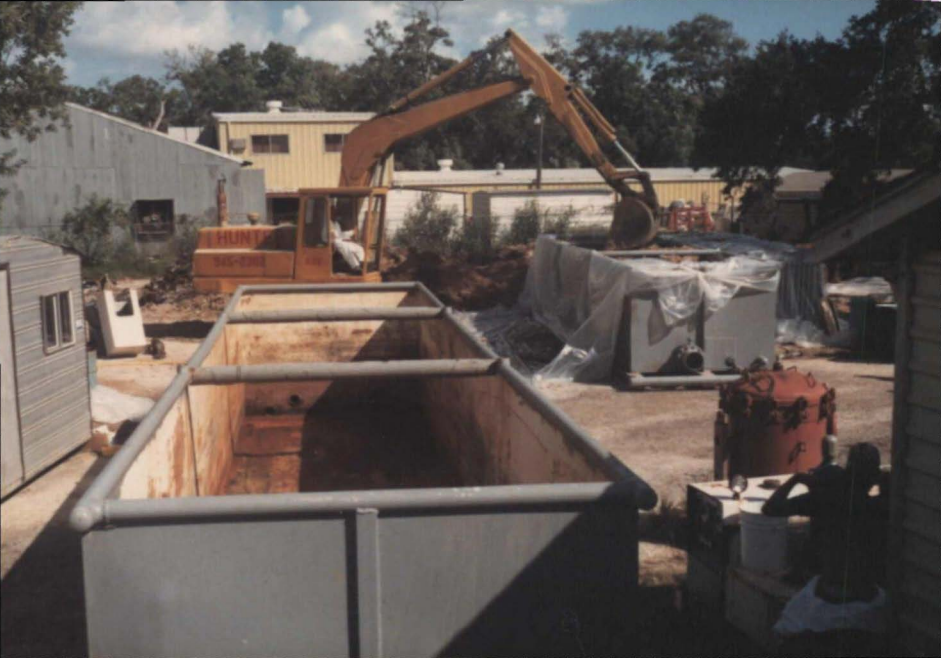
K-23

Another photo of loading of soil
into a mud tank. An empty
mud tank is shown to the left.
It is to be filled next.

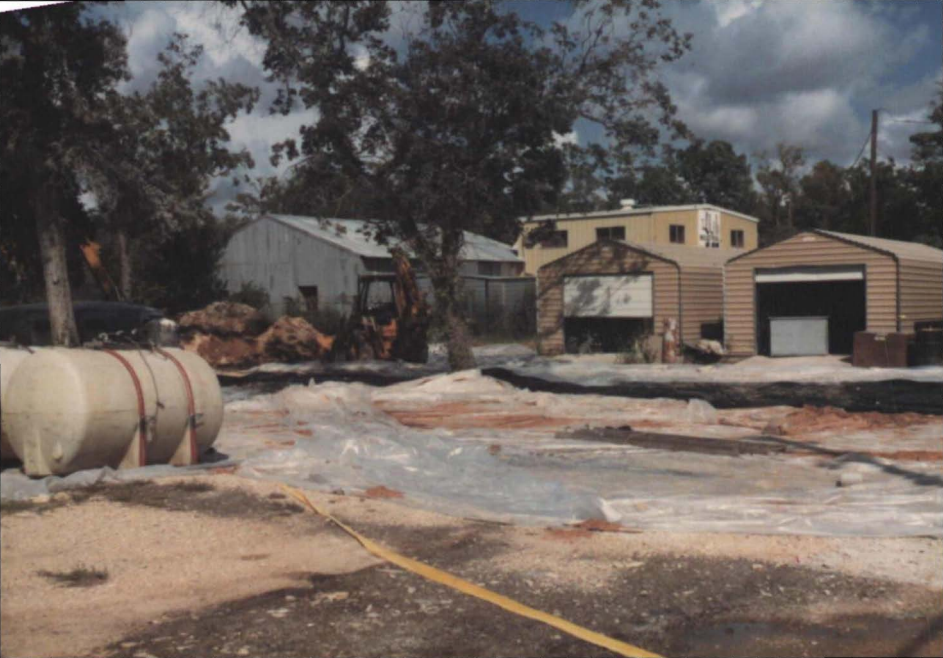
K-21

Spill area on BES property
covered with plastic
after the second set of
samples were taken for
PCB analysis.

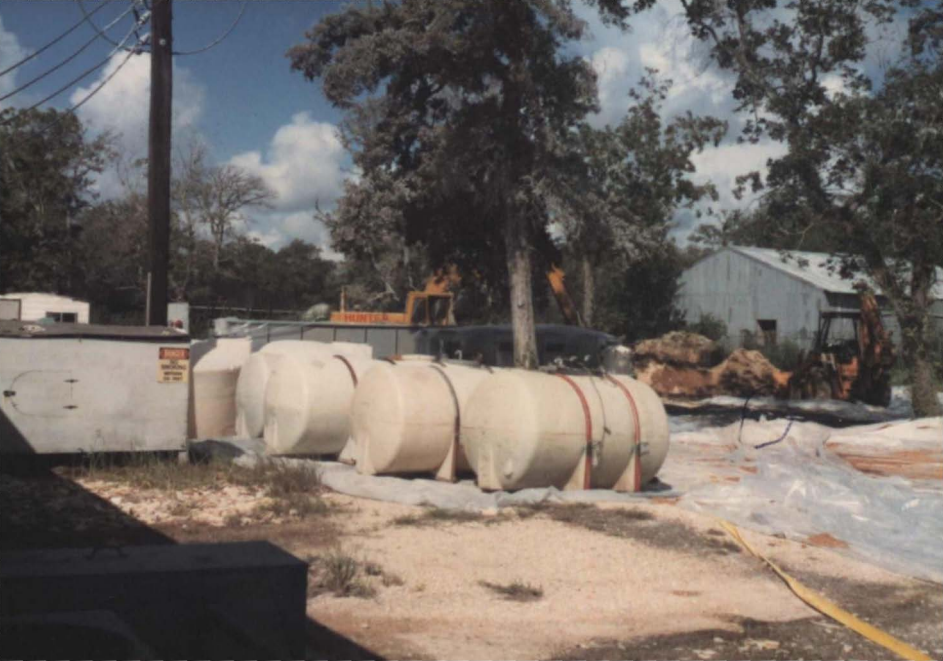
K-20

Photo of BEST #3 Sampling
site on BES property.

Sample #38 was taken
where circled.

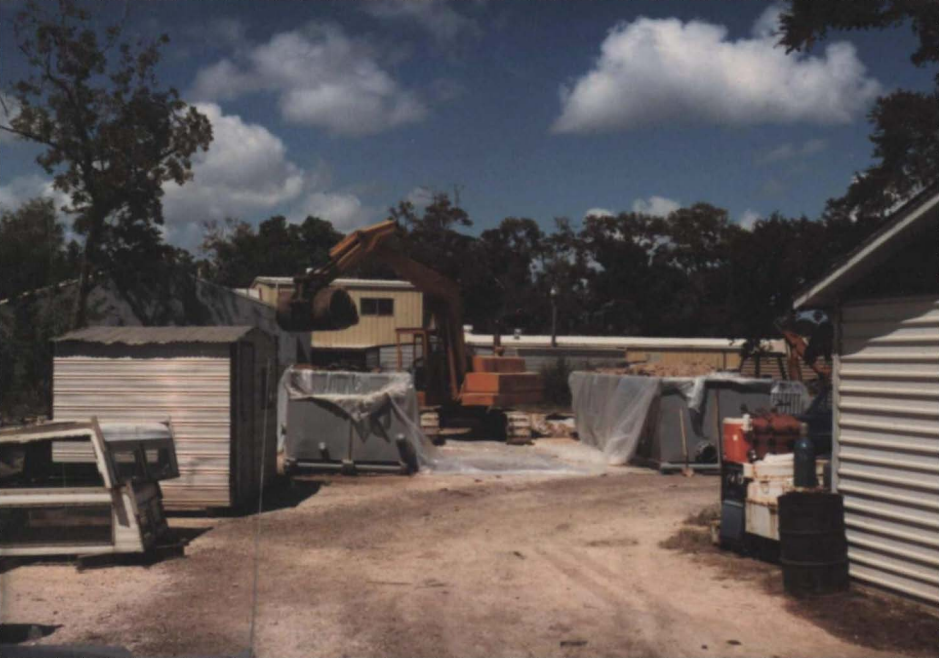
K-28

PCB Contaminated Soil is
being loaded into the
second mud tank.

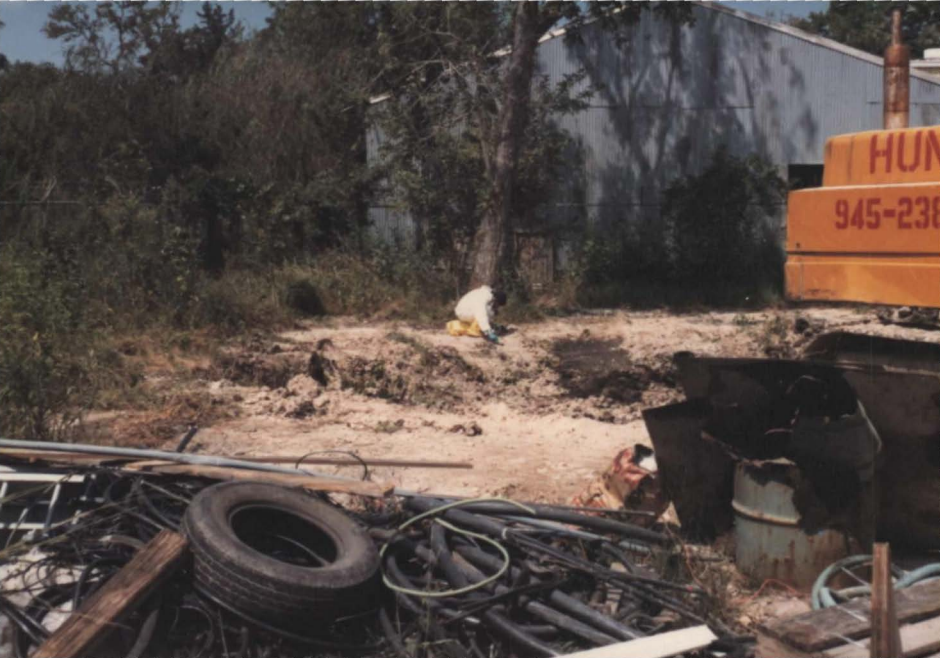
K-18
9/24/85-
1335-
North

Sampling of soil at the April
area after the second
cleanup. BES employee is
taking Sample # 36. IS
BEST #1 site.
